# IMPACTS OF HISTORIC LOG STORAGE ON EELGRASS (*ZOSTERA MARINA*) HABITAT IN THE SALISH SEA

Authors: Calvin Domarchuk-White<sup>1,2</sup>, Nikki Wright<sup>2</sup>, Nicole Christiansen<sup>3</sup>, Isobel Pearsall<sup>3</sup>

<sup>1</sup>BCIT; <sup>2</sup>SeaChange Marine Conservation Society; <sup>3</sup>Pacific Salmon Foundation

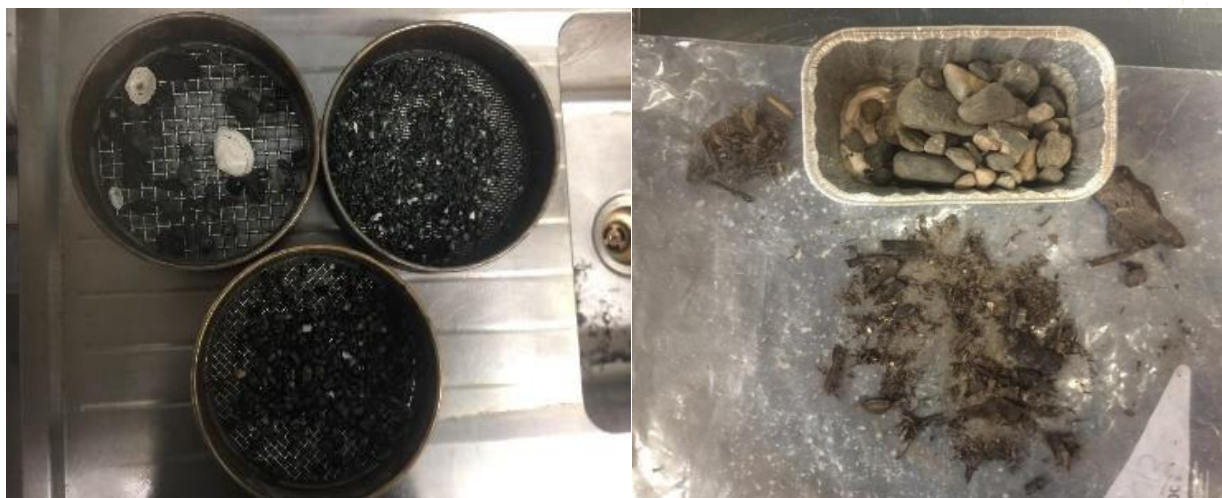
Figure 3. Left: samples were sorted through 9.5 mm, 4.75 mm, and 2.36 sieves to separate samples into four grain sizes. The finest grain sizes were washed through and collected in a pan. Right: the 9.5 mm and 4.75 mm grain sizes were hand-sorted into wood and bark, other organics, sediments, and shell components.

Each sample was sieved through a 9 mm, 4.75 mm, 2.36 mm mesh sieve, and any material finer was retained in a 'pan' (Figure 3) to aid in the drying and sorting processes. The sample portions were placed into aluminum baking tins and dried at 90°C in an oven for twenty-four hours to remove all moisture. The total dry weight of each grain size from each sample was noted.

The dry materials retained in the 9 mm and 4.75 mm sieves were hand-sorted into wood and bark, mineral, and biologic components (shell, vegetation, etc.) (Figure 3). The mass of wood and bark was calculated as a percent of the total dry mass, and then converted to mg/g. Whenever possible, wood and bark from each sample was then separated and calculated individually for further analysis.

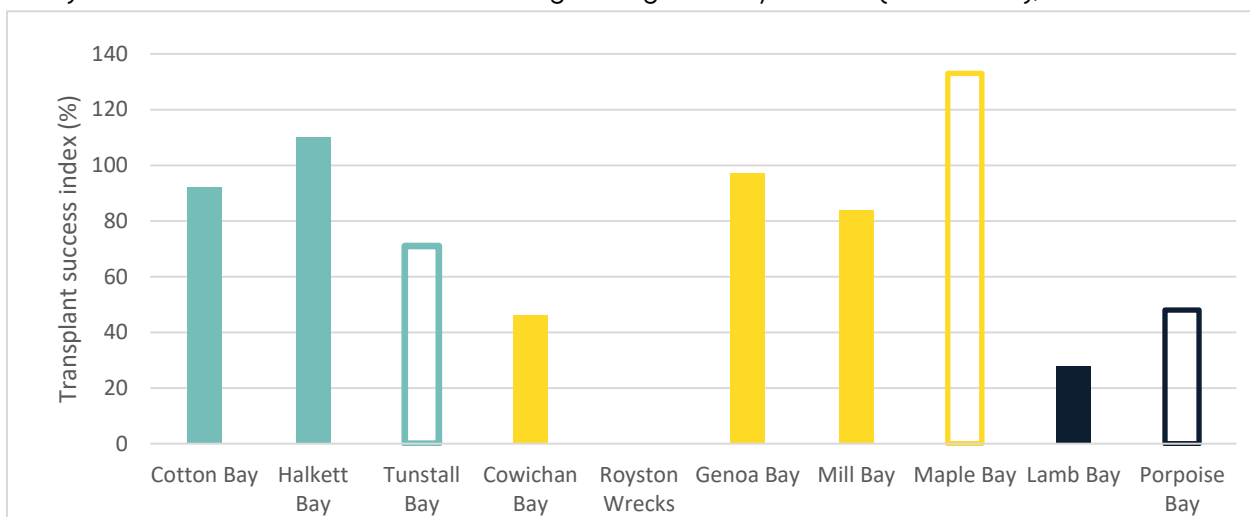
Figure 5. The relative success of each site's eelgrass transplant, calculated as the shoot density of the transplant as a percent of the shoot density of its reference bed by the end of the monitoring period. The three hollow bars represent the three reference sites with no history of log storage. Howe Sound sites have teal bars, East Coast Vancouver Island sites have yellow bars and Sechelt Inlet sites have dark blue bars.

The success of transplants varied across the sites, ranging from 0 at Royston Wrecks, meaning no transplants remained, to over 100 at Halkett Bay and Maple Bay, indicating the transplant sites had a higher density of shoots than the donor beds (Figure 5). On average, the transplants in the Howe Sound region fared the best (mean 91.0, Stdev 19.5), followed by the transplants on the East Coast of Vancouver Island (mean 72.0, Stdev 50.9), and transplants in Sechelt Inlet fared the worst (mean 38.0, Stdev 14.1). However, eelgrass transplants in reference sites did not reliably fare better than transplants in historic log storage sites. The mean transplant index score for sites with no log storage history was higher at 84.0 (Stdev 44.0) than the mean of the sites with a log storage history at 65.3 (Stdev 41.0), but this was

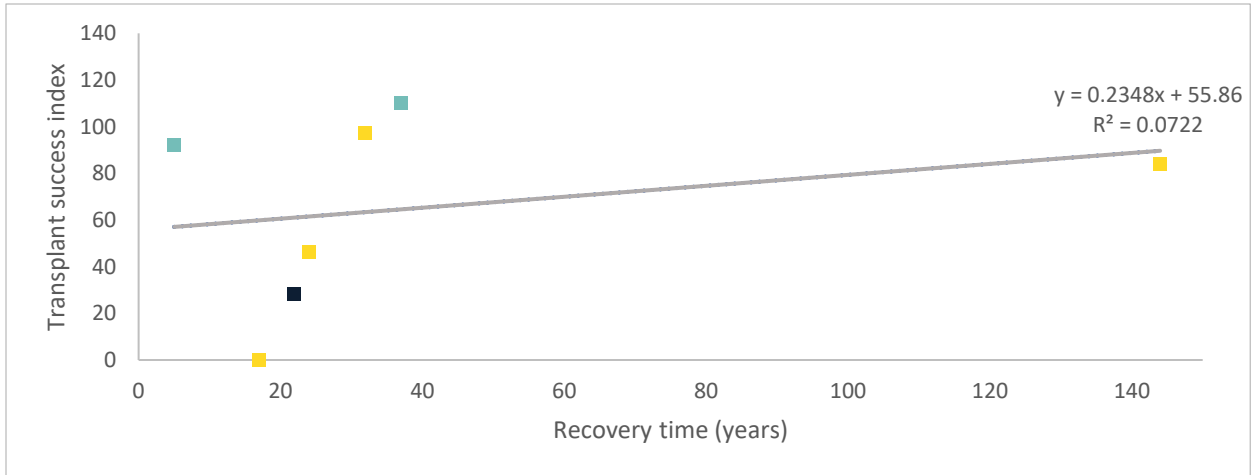
Figure 7. Eelgrass transplant success in comparison to recovery time since last use as a storage site in years. Transplant success is calculated as the shoot density of the transplant as a percentage of the shoot density of the reference bed. Only sites with log storage histories are depicted in this figure. Howe Sound sites have teal symbols, East Coast Vancouver Island sites have yellow symbols and Sechelt Inlet sites have dark blue symbols.

Regression analysis comparing the transplant success to the total years in use ( $R^2=0.0671$ ) and years since decommission ( $R^2=0.0722$ ) did not find a significant relationship (Figure 6 and Figure 7).

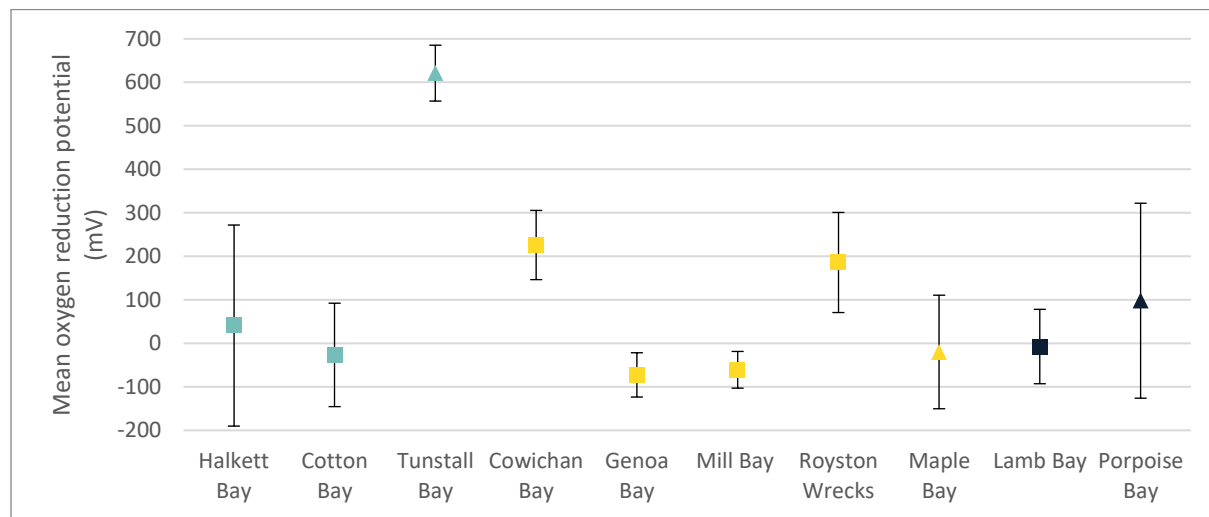
Figure 8. Average oxygen reduction potential by study sites. Sites with log storage histories are represented by square symbols and triangles are reference sites with no history of log storage. Howe Sound sites have teal symbols, East Coast Vancouver Island sites have yellow symbols and Sechelt Inlet sites have dark blue symbols. Halkett Bay n=7, Cotton Bay n=8, Tunstall Bay n=3, Cowichan Bay n=7, Genoa Bay n=7, Mill Bay n=7, Royston Wrecks n=6, Maple Bay n=3, Lamb Bay n=8, Porpoise Bay n=3.

Pore-water oxygen reduction potential (ORP) in marine sediments typically ranges from +500 mV in oxic sediments to -200 mV in anoxic sediments. Negative oxygen reduction potential indicates reduction and may result in the production of sulphides (Sutherland et al. 2006, Schulz 2000). Field measurements of ORP were indicative of anoxic conditions at several of the study sites. The average ORP at each site ranged from -72.4 mV at Genoa Bay to 621.2 mV at Tunstall Bay. The mean ORP of the sites with a logging history (n=7) was lower at 40.8 mV (Stdev 119.3) compared with the sites with no logging history (n=3) at 233.0 mV (Stdev 341). However, measurements were highly variable between sites and across each site individually (Figure 8) and the ANOVA did not find a statistically significant difference. Regression analysis did not find a significant relationship between ORP and transplant success ( $R^2=0.014$ ) (Figure 9). Further analysis of the data revealed a seasonal influence to the readings, likely confounding the results. See Appendix D for pore-water reduction potential data.

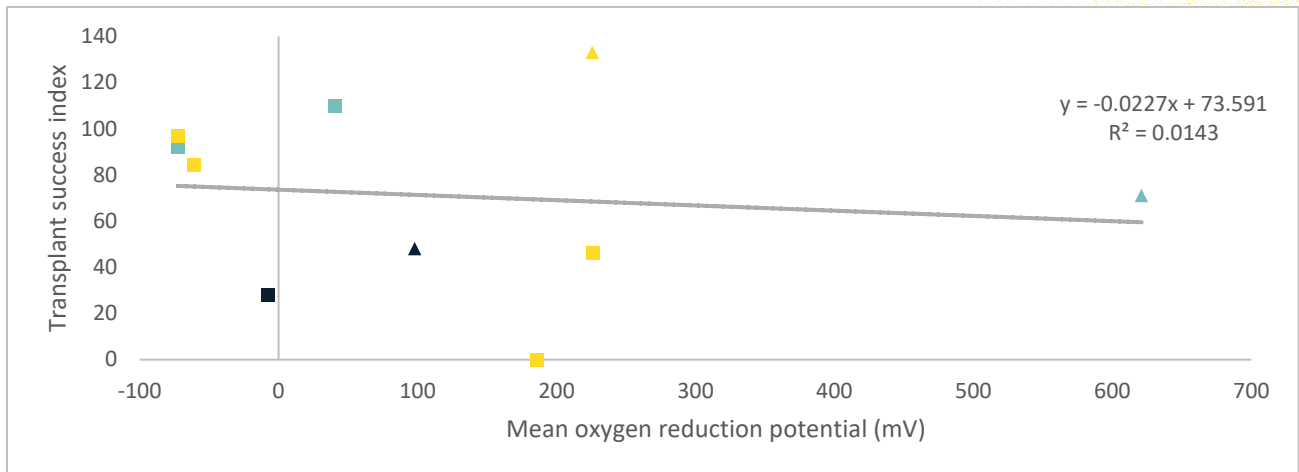
Figure 9. Eelgrass transplant success in comparison to mean oxygen reduction potential (mV). Transplant success is calculated as the shoot density of the transplant as a percentage of the shoot density of the reference bed. Sites with log storage histories are represented by square symbols and triangles are reference sites with no history of log storage. Howe Sound sites have teal symbols, East Coast Vancouver Island sites have yellow symbols and Sechelt Inlet sites have dark blue symbols.

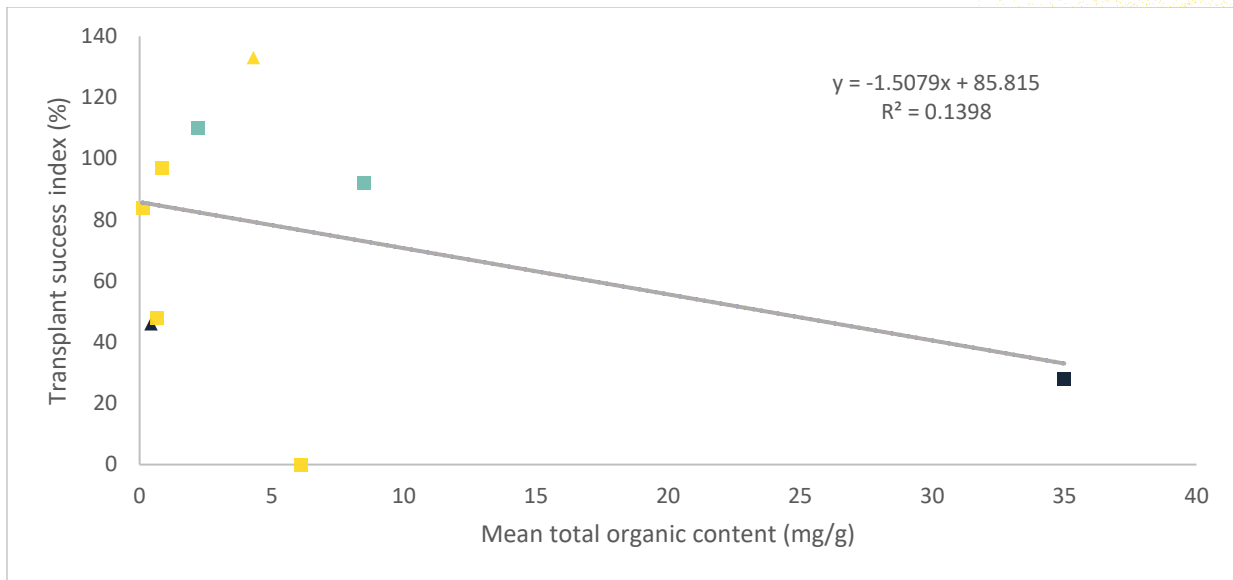
Figure 10. Eelgrass transplant success in comparison to mean total organic content (mg/g). Transplant success is calculated as the shoot density of the transplant as a percentage of the shoot density of the reference bed. Sites with log storage histories are represented by square symbols and triangles are reference sites with no history of log storage. Howe Sound sites have teal symbols, East Coast Vancouver Island sites have yellow symbols and Sechelt Inlet sites have dark blue symbols. The Tunstall Bay site sample was lost due to technical difficulties in the field. See Appendix E for sediment total organic composition data.

The mean sediment total organic content was greater at the sites with a logging history (n=6) at 13.5 mg/g (Stdev 25.6) than at the sites with no logging history (n=2) at 2.49 mg/g (Stdev 2.58). Again, sites were highly variable and there was a small sample size for the control sites, as such the ANOVA did not find a statistical difference between historic log storage and control sites. Regression analysis did not reveal any significant relationship between organic content and transplant success ( $R^2=0.1398$ ) (Figure 10).

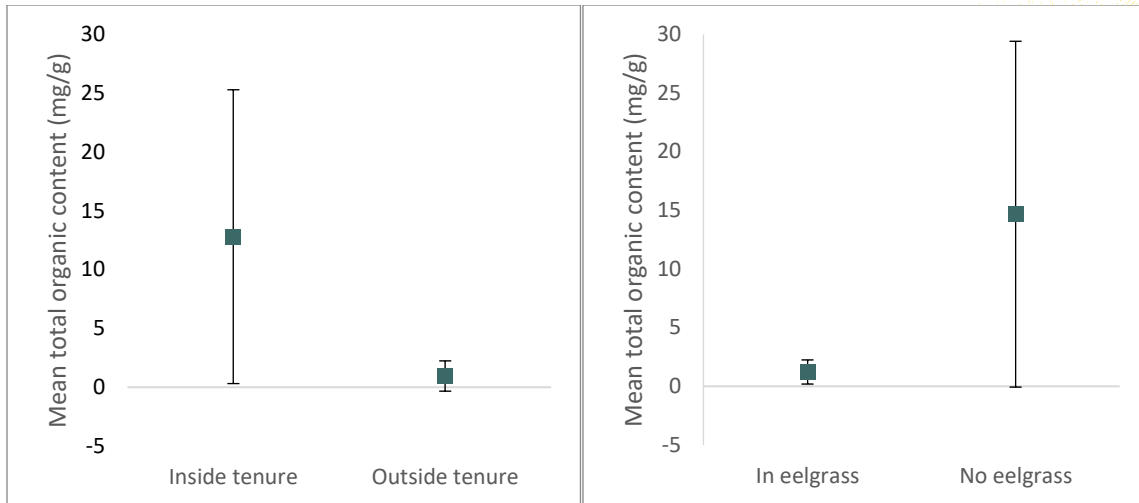
Figure 11. Average total organic content of sediment samples (mg/g) taken across all study sites. The graph on the left compares average total organic content from sediment samples taken from inside a historic log storage tenure (n = 15) to that of sediment samples taken where no tenure existed (n = 8). The graph on the right compares the average total organic content of sediment samples taken within or just beside eelgrass beds (n = 10) to that of sediment samples taken in areas with no eelgrass (n = 13).

On average, samples taken inside historic log storage tenures contained 12.8 mg/g more organic content than samples taken outside tenures, however values were variable and this difference was not statistically significant. Sediment samples taken where eelgrass lived contained very little organic content, less than 2 mg/g (Figure 11).

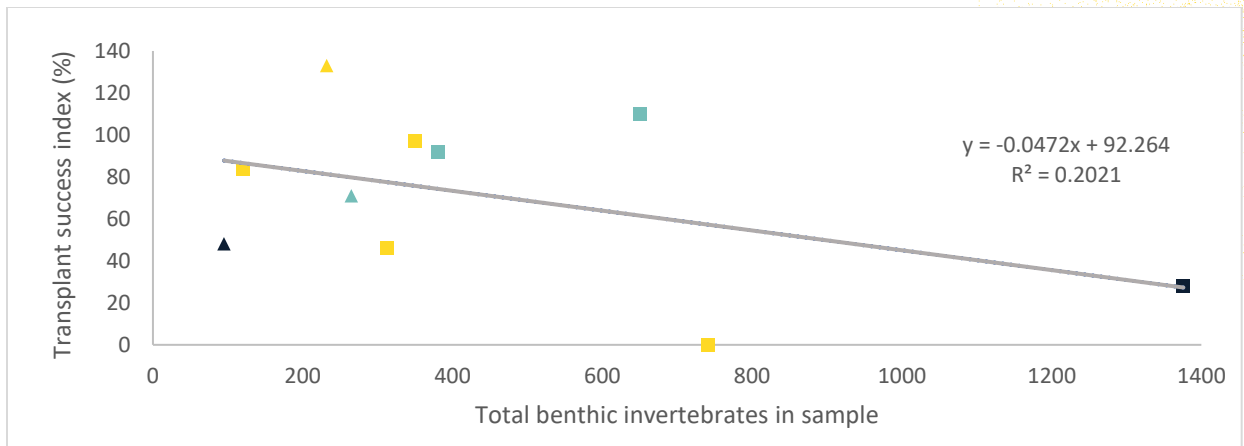
Figure 17. Eelgrass transplant success compared with the total benthic invertebrates identified from the Ponar grab sample collected adjacent to transplants. Transplant success is calculated as the shoot density of the transplant as a percentage of the shoot density of the reference bed. Sites with log storage histories are represented by square symbols and triangles are reference sites with no history of log storage. Howe Sound sites have teal symbols, East Coast Vancouver Island sites have yellow symbols and Sechelt Inlet sites have dark blue symbols.

Regression analysis did not reveal a significant relationship between the total number of species or Pielou's evenness index and transplant success (Figure 17 and Figure 20). However, there was a significant negative relationship between transplant success and Margalef index ( $R^2=0.601$ ,  $p<0.01$ ) (Figure 18). Related, the total unique taxa also showed a negative relationship ( $R^2=0.455$ ,  $p=0.01$ ) with transplant success (Figure 19).

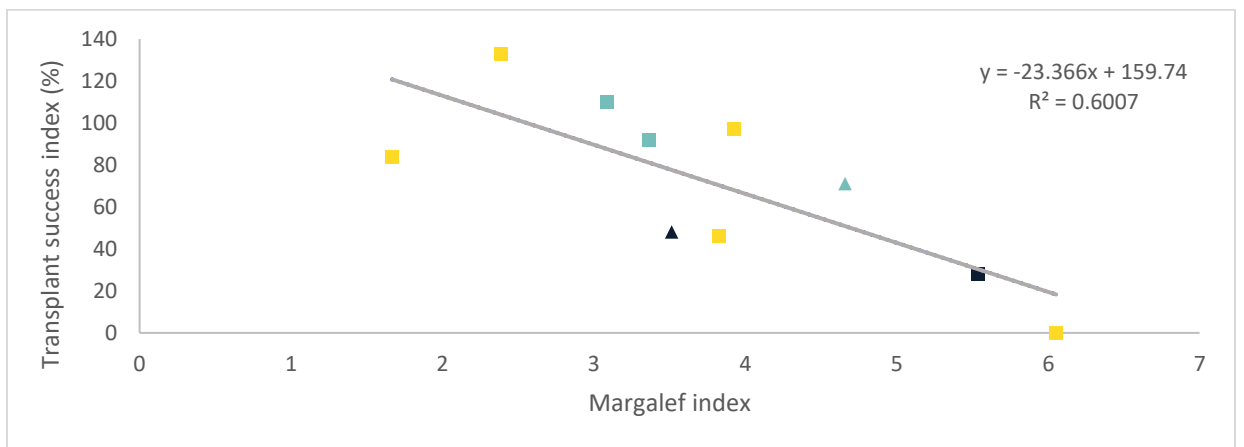
Figure 18. Eelgrass transplant success compared with the total benthic Margalef index from the Ponar grab sample collected adjacent to transplants. Transplant success is calculated as the shoot density of the transplant as a percentage of the shoot density of the reference bed. Sites with log storage histories are represented by square symbols and triangles are reference sites with no history of log storage. Howe Sound sites have teal symbols, East Coast Vancouver Island sites have yellow symbols and Sechelt Inlet sites have dark blue symbols.

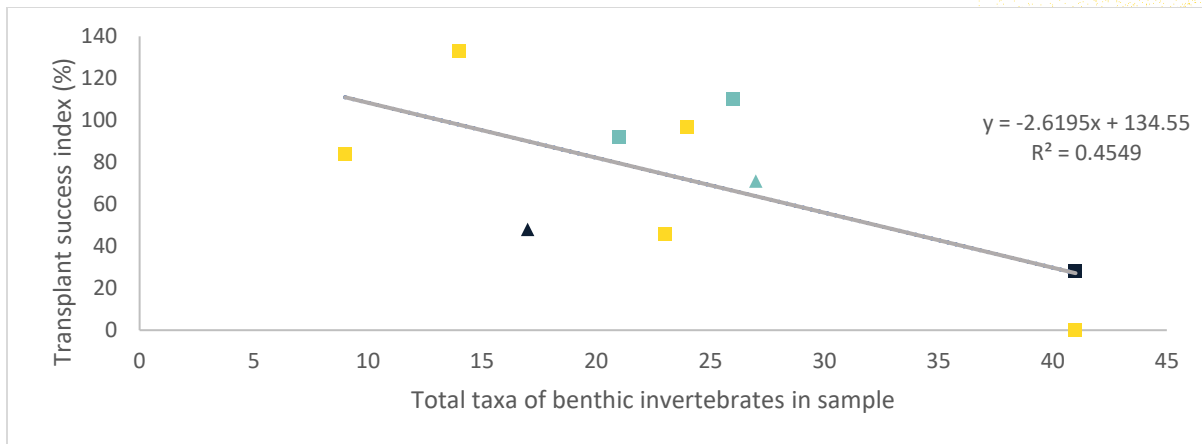
Figure 19. Eelgrass transplant success compared with the total benthic invertebrate taxa identified from the Ponar grab sample collected adjacent to transplants. Transplant success is calculated as the shoot density of the transplant as a percentage of the shoot density of the reference bed. Sites with log storage histories are represented by square symbols and triangles are reference sites with no history of log storage. Howe Sound sites have teal symbols, East Coast Vancouver Island sites have yellow symbols and Sechelt Inlet sites have dark blue symbols.

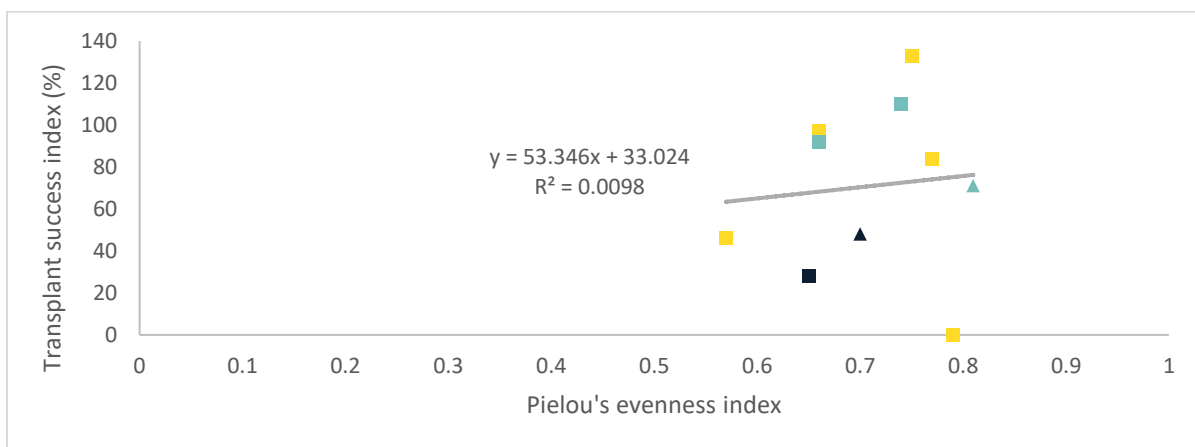
Figure 20. Eelgrass transplant success compared with the Pielou's evenness index from the Ponar grab sample collected adjacent to transplants. Transplant success is calculated as the shoot density of the transplant as a percentage of the shoot density of the reference bed. Sites with log storage histories are represented by square symbols and triangles are reference sites with no history of log storage. Howe Sound sites have teal symbols, East Coast Vancouver Island sites have yellow symbols and Sechelt Inlet sites have dark blue symbols.

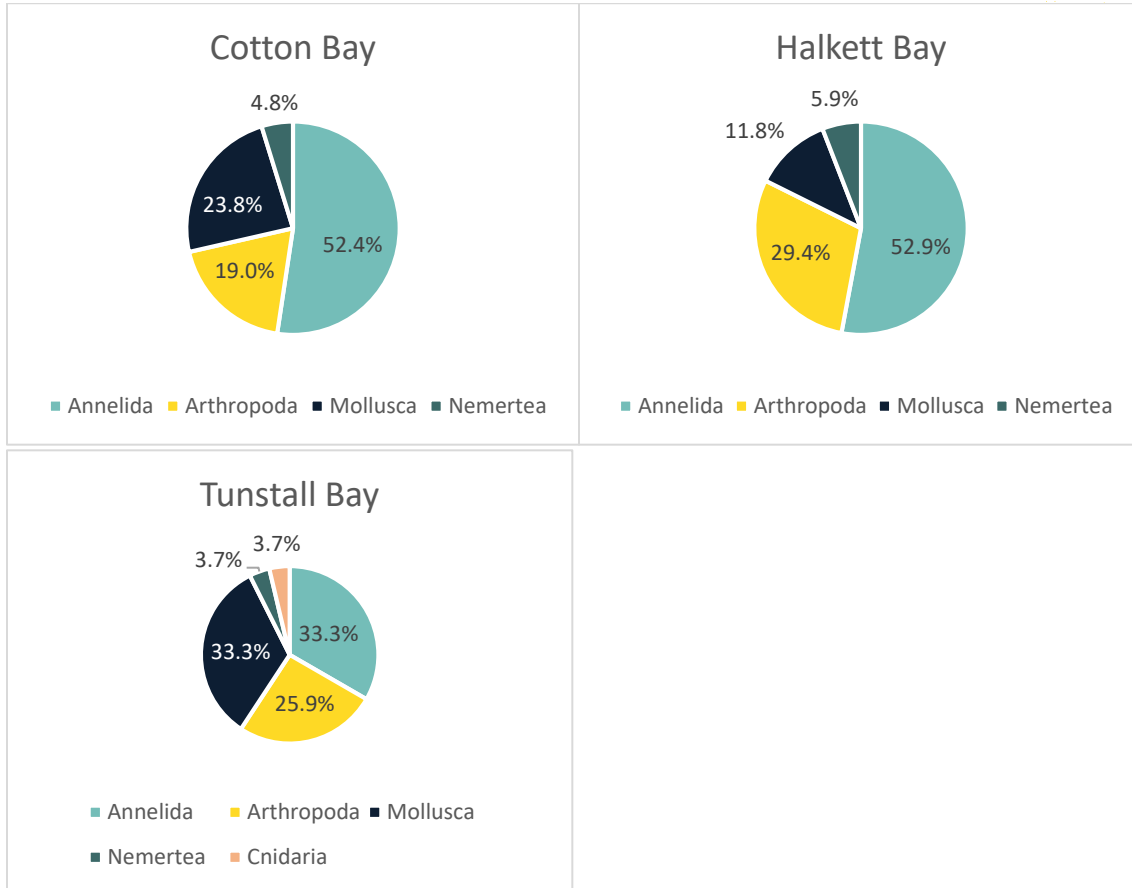
Figure 21. Invertebrate community composition by phyla for the Ponar grab samples from the Howe Sound sites.

Figure 21 – Figure 22). In general, annelids were the most common phyla with arthropods and mollusks making up the majority of the remaining phyla present in the samples.

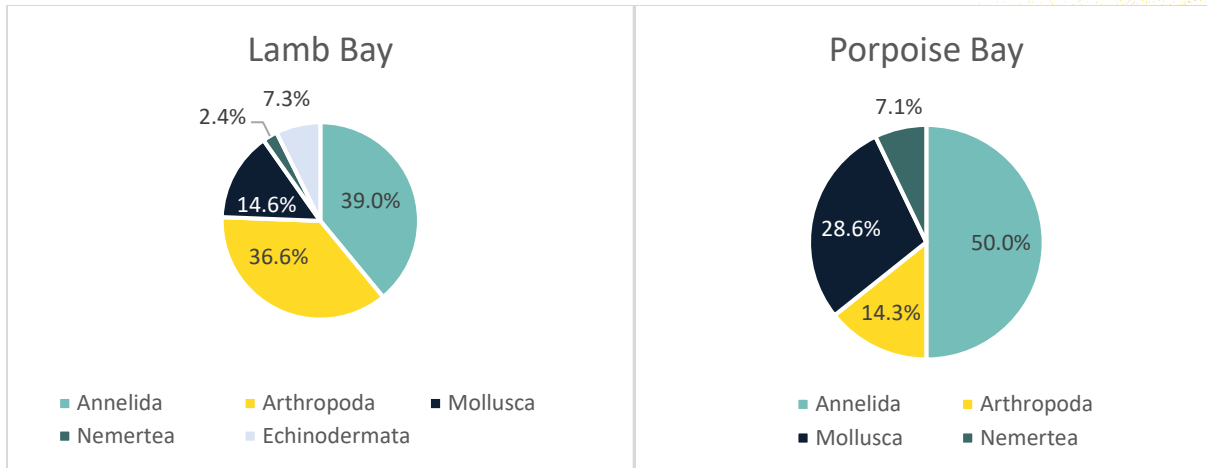
Figure 23. Invertebrate community composition by phyla for the Ponar grab samples from the Sechelt Inlet sites.

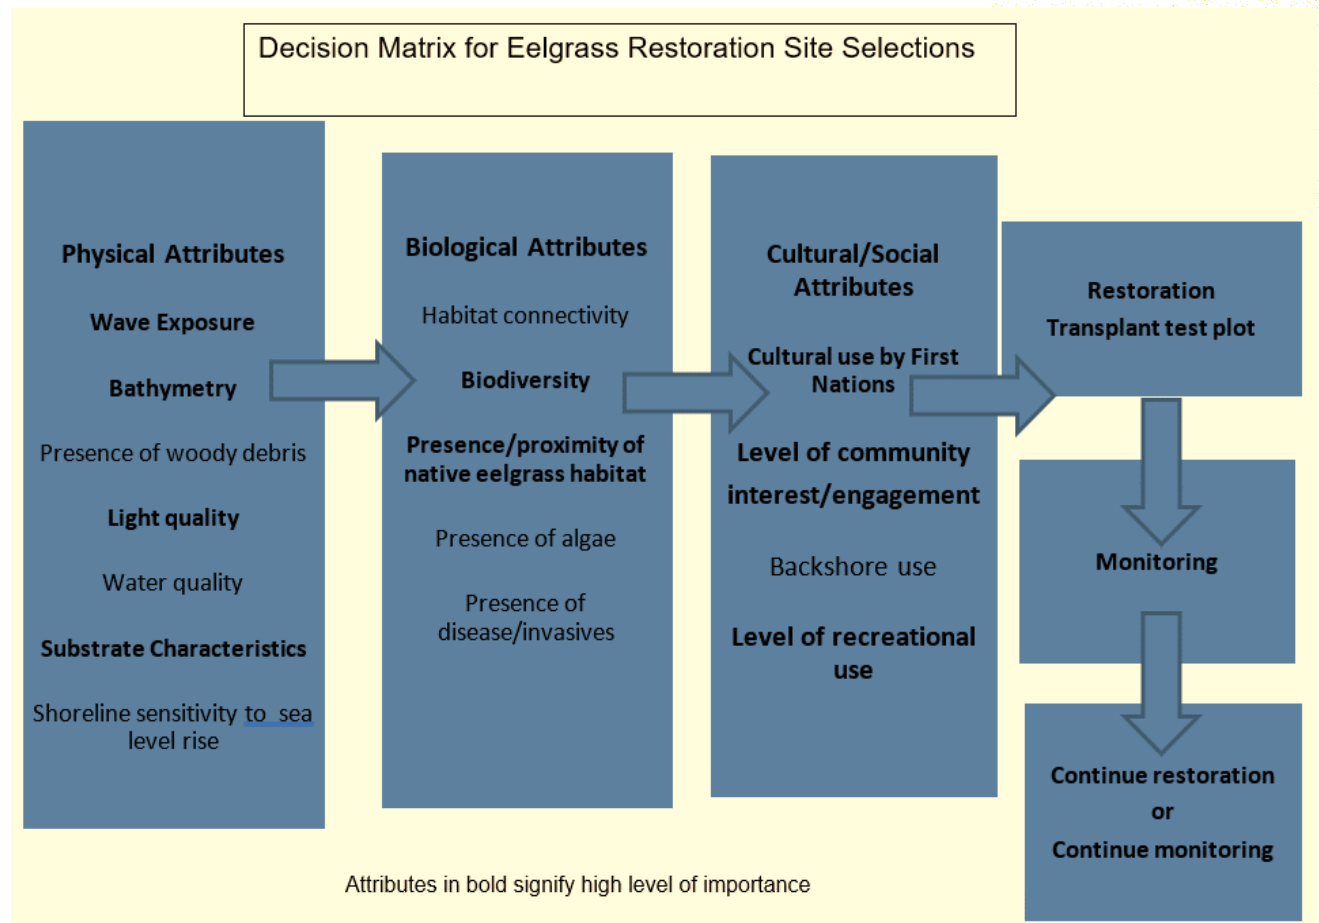
## C. Eelgrass Transplant Selection Decision Matrix

Eelgrass transplant site selection matrix used by SeaChange Marine Conservation, reproduced with permission.
